HOME INSPECTION REPORT

1628 Northmount Ave
Mississauga

Inspection Date: Oct 23 2017

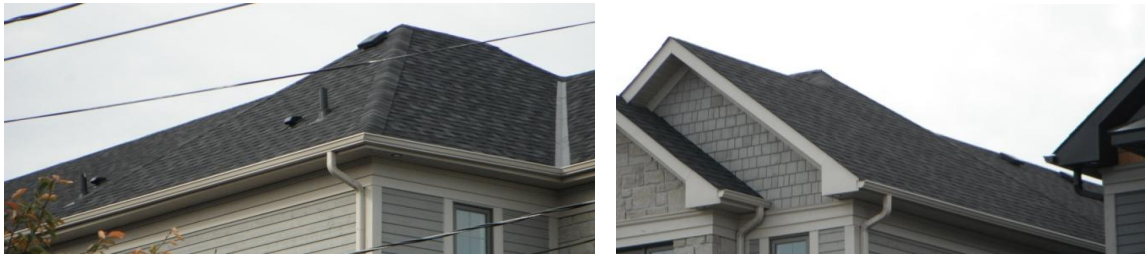
Sloped Surface: [new surface in good repair](#)

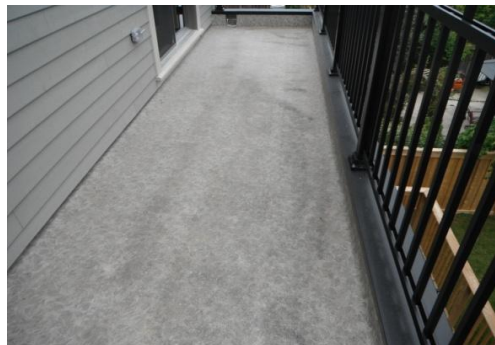
Flat Surface: [new surface in good repair](#)

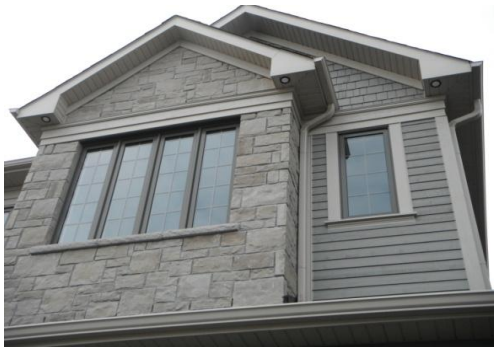
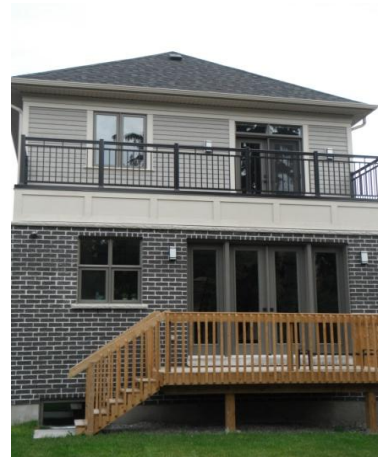
WALL SURFACES: new surfaces in good condition

DECK new deck

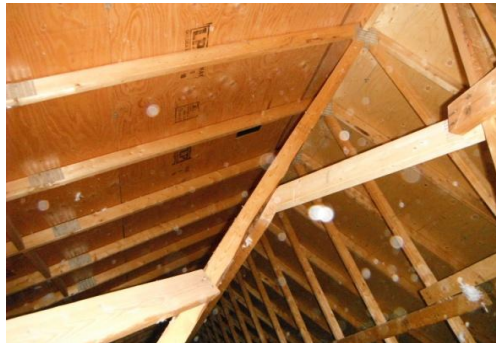
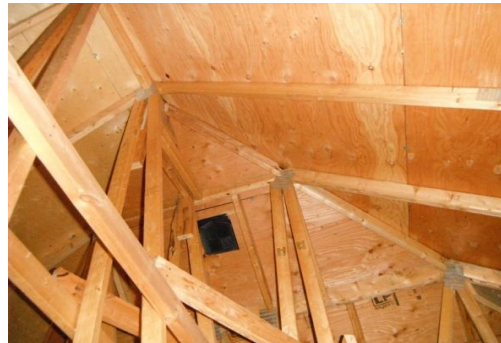
overall well built house

ROOF: in new condition

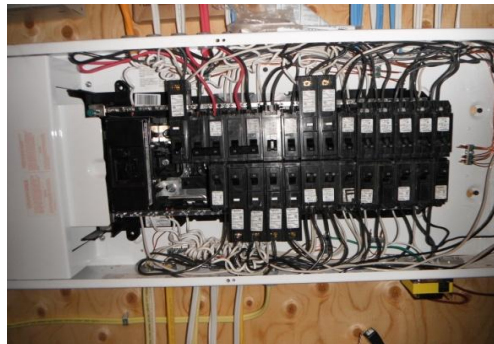
SERVICE PANEL: **new panel in good repair**

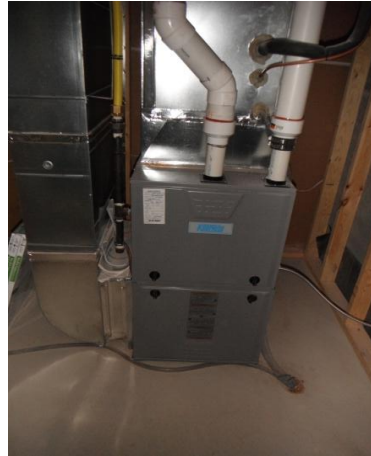
FORCED AIR FURNACE: [service annually](#)

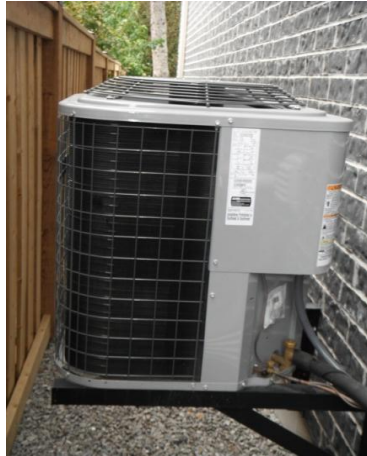
AIR CONDITIONER: [service annually](#)

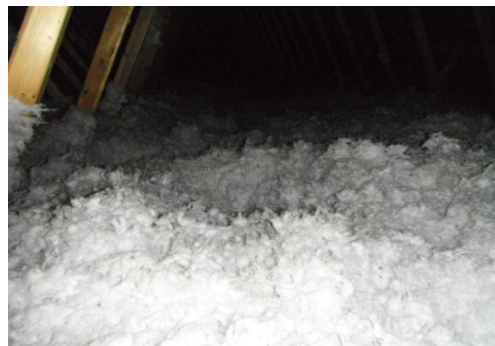
ROOF SPACE: [above average insulation](#)

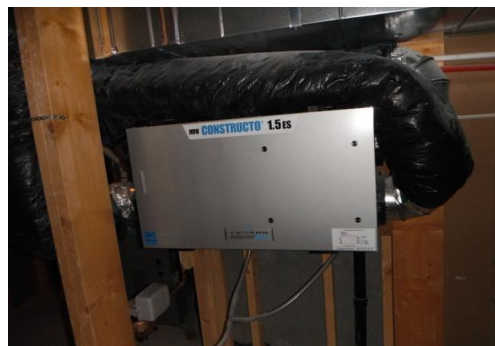
Heat Recover Ventilator: [service annually](#)
