HOME INSPECTION REPORT

4 Norval St
Toronto

Prepared by: Bob Papadopoulos P.Eng., RHI *

Inspection Date: Sept 1 2020
report modified Mar 2021 for new Furnace

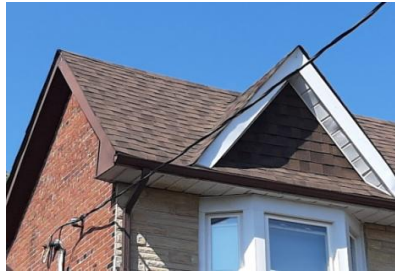
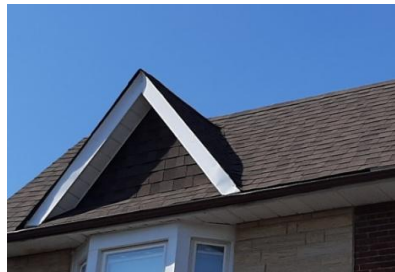
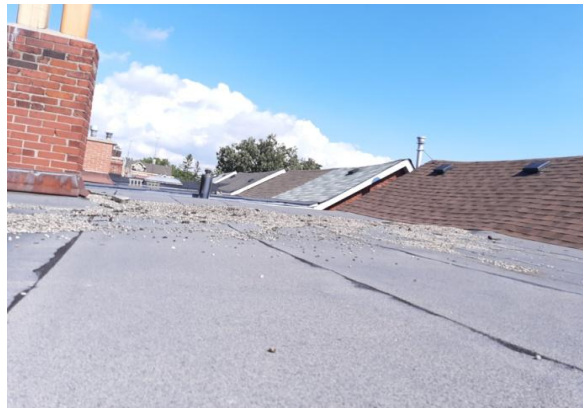
Sloped Surface: [new surface in good repair](#)
Flat Surface: [overall surface in good repair](#)

Note: Recommend Annual Maintenance Contract for Roof Surface, Flashing Details and Chimney(s)

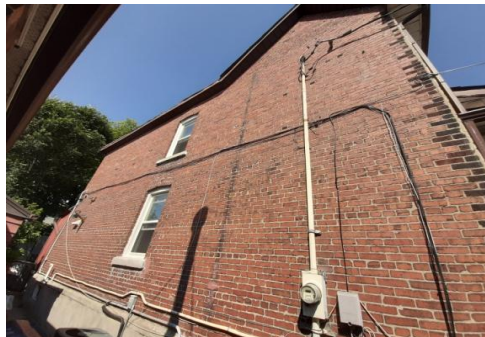
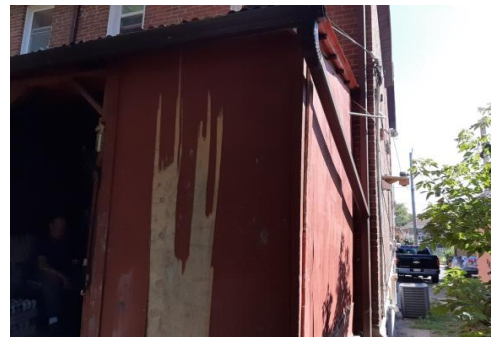
****Gutters/Downspouts:** requires maintenance
 extend 6-ft away from house

Plywood: rear extension - requires repairs - cover with siding

DOORS/WINDOWS: overall in good repair

Note: Maintain Gutters & Downspouts annually. Extend Downspouts at least 6-feet away from the house

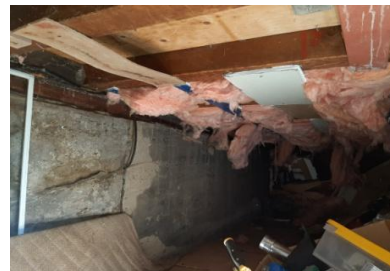
PORCH overall in good repair, underside of floor requires insulation repairs then cover with plywood

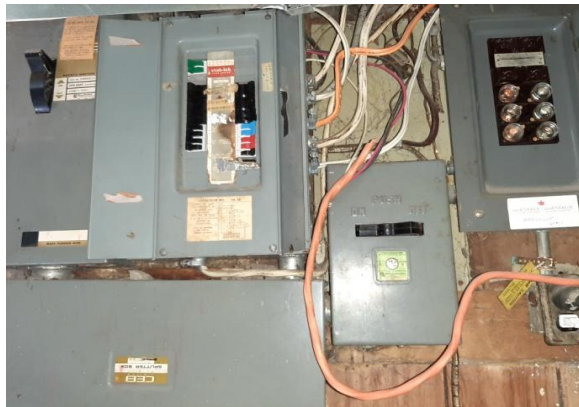
SERVICE PANEL: restricted access therefore covers not removed, overall recommend removing and replacing with larger combination panel when renovating

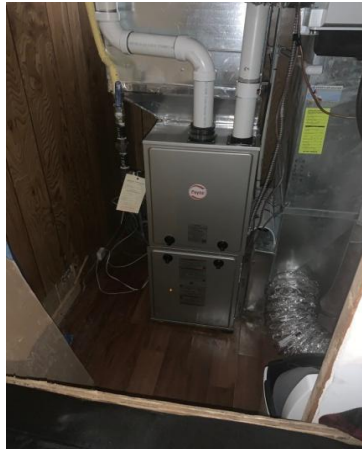
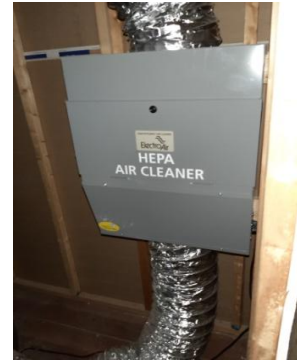
FORCED AIR FURNACE: [service annually](#)

Filter: [high quality unit - service as per owners manual](#)

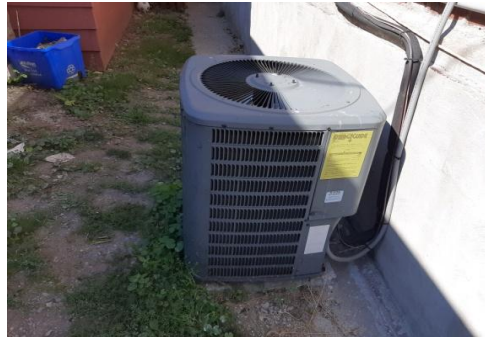
Outdoor Coil: [adjust so unit is level](#)

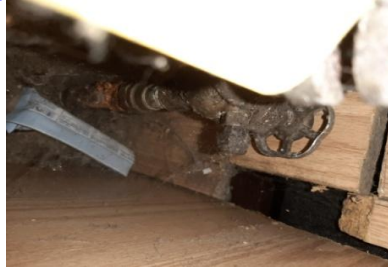
PLUMBING The galvanized steel water main should be upgraded to copper in the short term. The supply piping in the house is copper. Floor drain not visible.

WATERMAIN: [corroded- risk of leaking. contact city to arrange replacement](#)

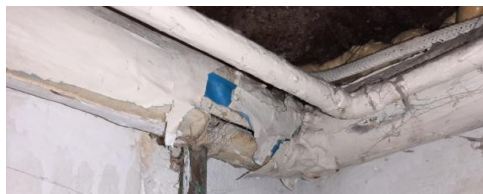
Comments: [basement rear room: insulation on pipes may contain asbestos encapsulating the insulation is often the best approach](#)
[Environmental Consultants can assist if this is a concern](#)
