HOME INSPECTION REPORT

77 Randolph Rd

Toronto

Inspection Date: Jan 2 2021

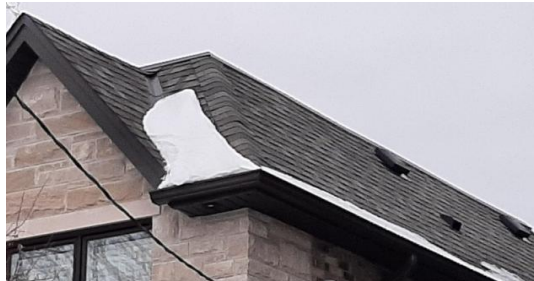
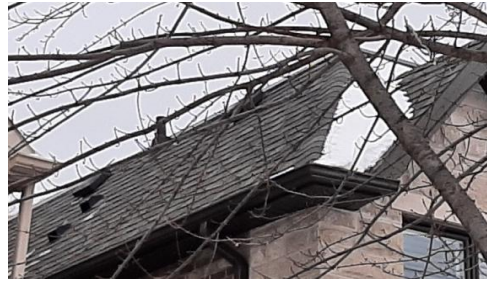
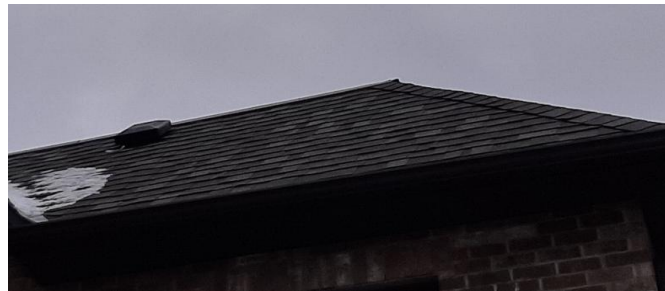
Sloped Surface: [surfaces in good repair](#)

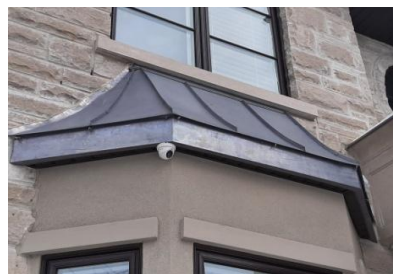
Bay(s): [surfaces in good repair](#)

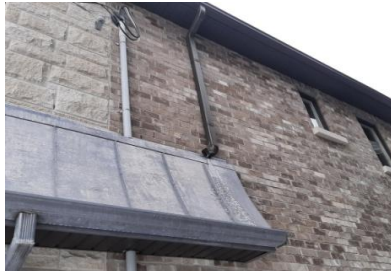
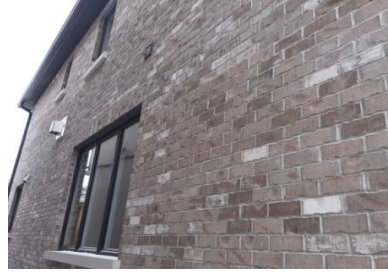
WALL SURFACES: overall in good repair
DOORS/WINDOWS: in good repair, good quality units overall

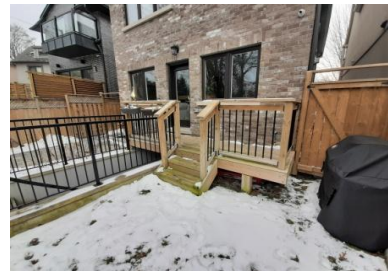
DECK overall in good repair

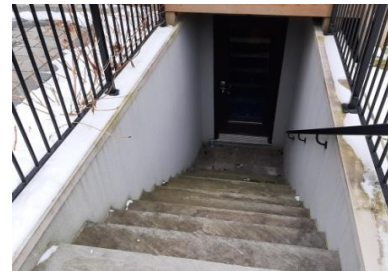
**BASEMENT WALKOUT: overall well built

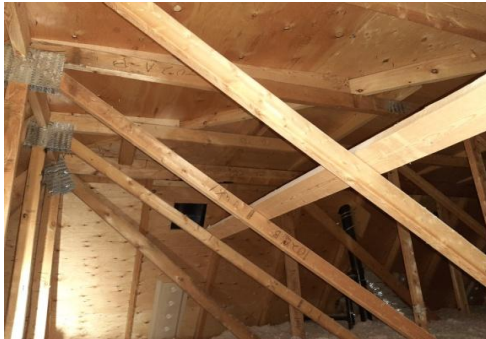
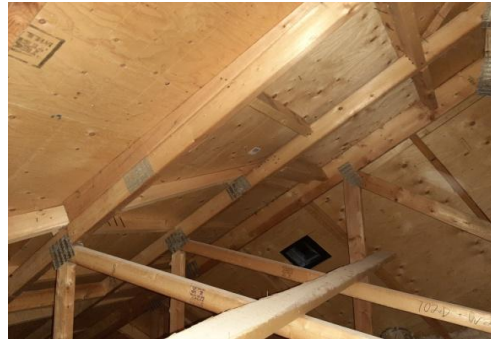
ROOF: overall in good repair

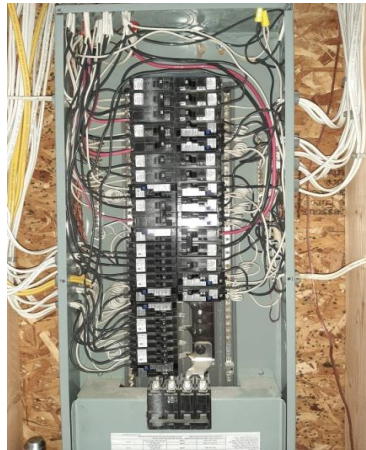
SERVICE PANEL: **overall in good repair**

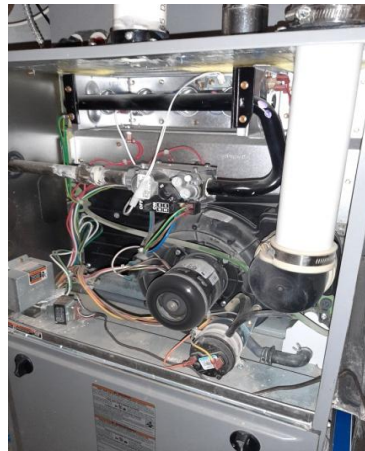
FORCED AIR FURNACE: [service annually](#)

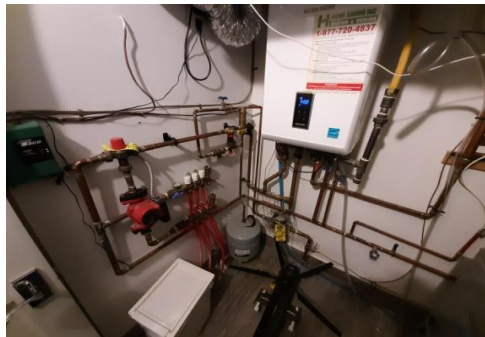
COMBINATION SYSTEM: [provides basement floor heating via hot water radiant](#)

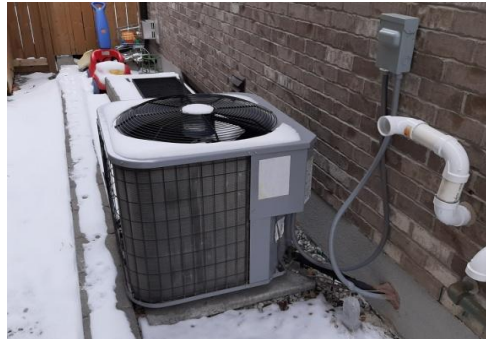
AIR CONDITIONER: not tested: should be serviced before using
service annually

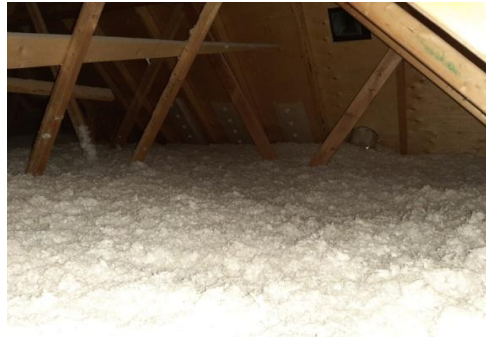
ROOF SPACE: [insulation and ventilation is adequate](#)

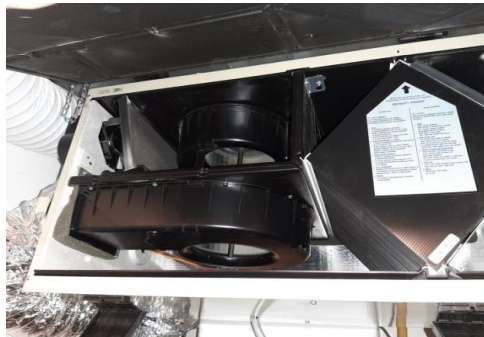
Heat Recover Ventilator: [service annually](#)
